# Manhole Inspection Summary

Manhole # S37CC1014MH

Insp Date: **12/12/06 10:56 AM**

**Location** Address: **3600 OLD YORK RD**

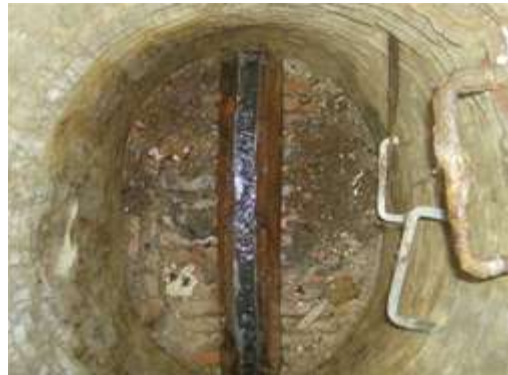
Top View

Corroded steps. Evidence of surcharge - Bench debris.

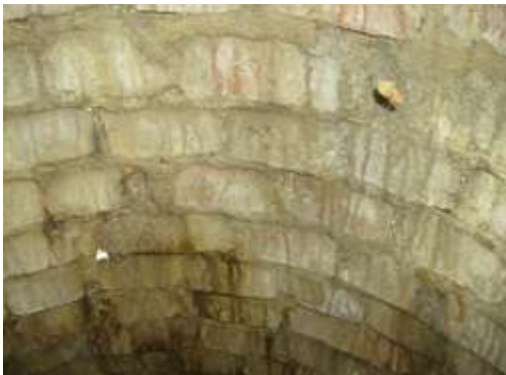
Defect

Barrel infiltration.

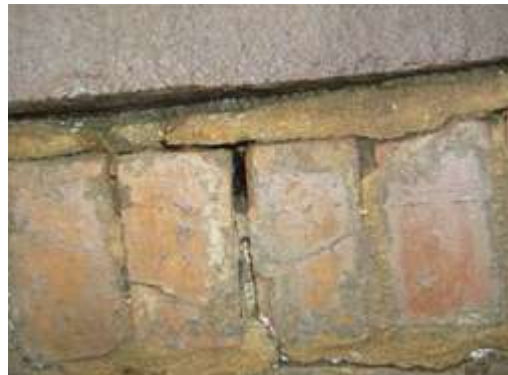
Defect

Frame leaks. Adjustment deterioration and infiltration.

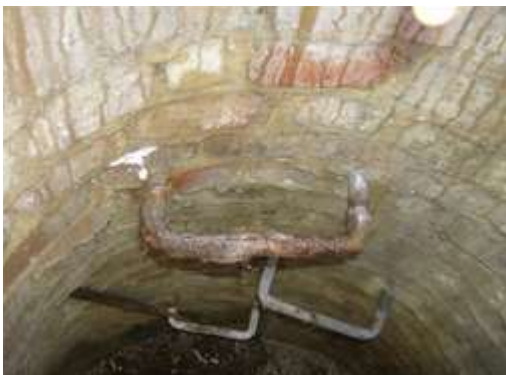
Defect

Adjustment and Barrel infiltration.

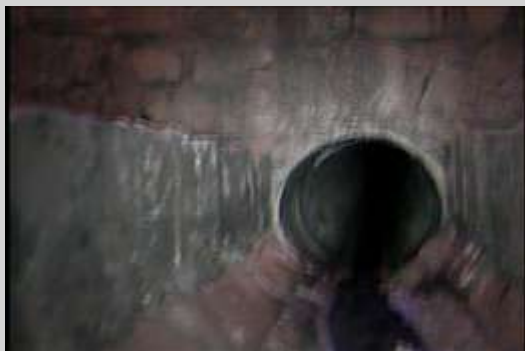
### 8 in. Circular Gravity Sewer Pipe In @ 6 O'Clock

Channel deterioration.
